Manhole Inspection Summary

Manhole # S29G__003MH

Insp Date: **5/26/09 2:08 PM**

Location Address: **10 Baltimore**

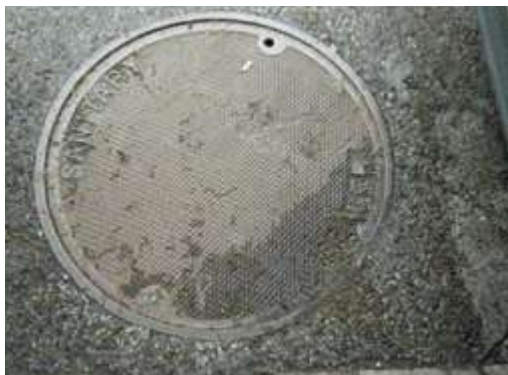
Miscellaneous

mh cover

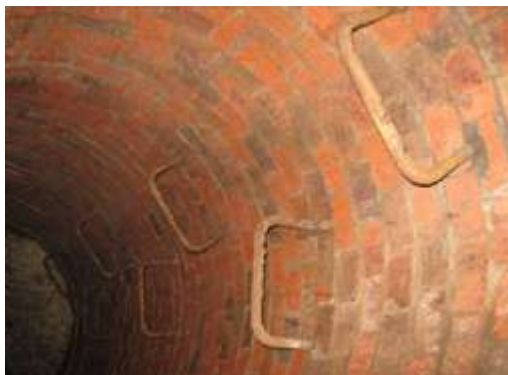
Defect 6

Steps Count: **7** Missing: **0** ☒ **Corroded**

corroded rungs

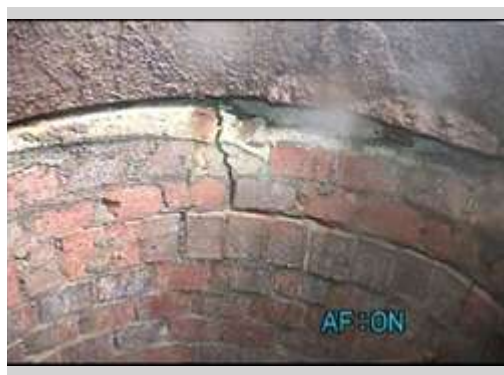
Defect 4

Condition: ☐ Sound ☒ **Cracked** ☐ Root Intrusion ☐ Loose Brick ☐ Deteriorated

crack in chimney

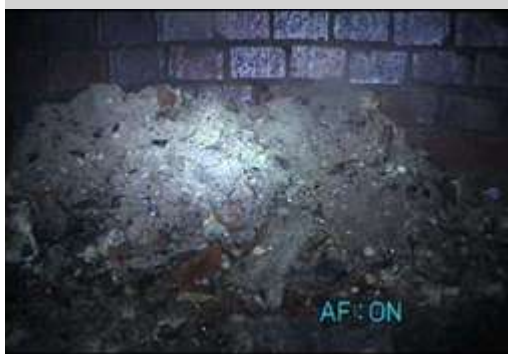
Defect 2

Condition: ☐ Sound ☐ Cracked ☐ Root Intrusion ☐ Deteriorated ☐ Leaks ☒ **Debris**

debris on bench

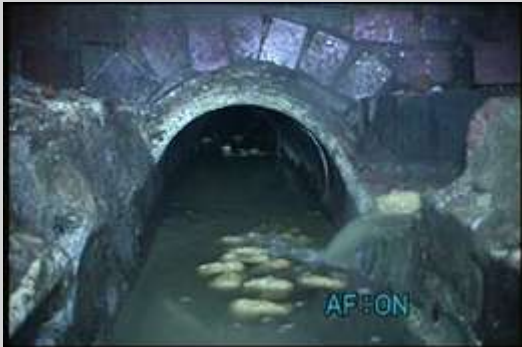
12 O'Clock Outflow

Pipe Height: **10.8** (in.) Rod and Bar (Angled)
Pipe Material: **Clay** ☐ Pipe Lined
Invert Depth: **12.36** (ft.) Flow Characteristics: **Slow**
Deposits: ☒ None ☐ Mud ☐ Sludge ☐ Debris ☐ Grease
Silt Depth: **0** (in.) Deposits Extent:
Infiltration: **None** Pipe Seal Cond: **Sound**

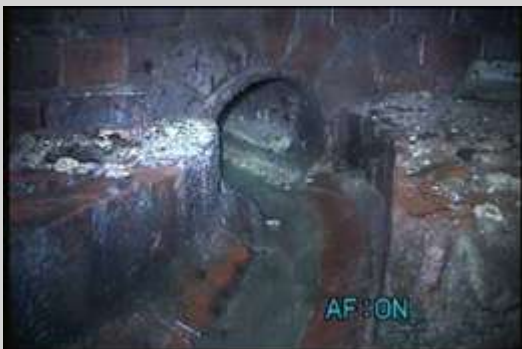
3 O'Clock Inflow

Pipe Height: **8.4** (in.) Rod and Bar (Angled)
Pipe Material: **Clay** ☐ Pipe Lined
Invert Depth: **10.90** (ft.) Flow Characteristics: **Slow**
Deposits: ☒ None ☐ Mud ☐ Sludge ☐ Debris ☐ Grease
Silt Depth: **0** (in.) Deposits Extent:
Infiltration: **None** Pipe Seal Cond: **Sound**

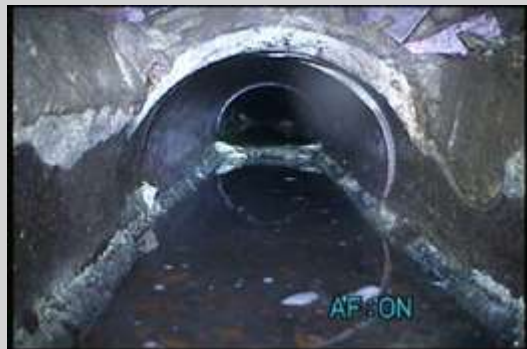
6 O'Clock Inflow

Pipe Height: **10.8** (in.) Rod and Bar (Angled)

Pipe Material: **Clay** ☐ Pipe Lined

Invert Depth: **12.30** (ft.) Flow Characteristics: **Fast**

Deposits: ☒ None ☐ Mud ☐ Sludge ☐ Debris ☐ Grease

Infiltration: **None** Pipe Seal Cond: **Sound**
